EverRide Generation 1 and early Generation 2 Warrior™ Mowers

SAFETY CAMPAIGN

May 15, 2005

EverRide is announcing a safety recall campaign on 2004 and early 2005 Warrior Zero-Turn Mowers.

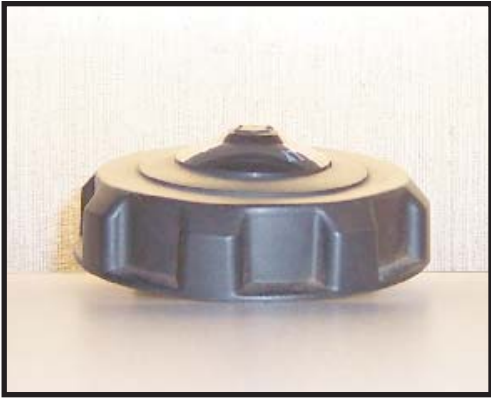
Old Style Fuel Cap, P/N 180975

TOP IDENTIFICATION

Text: Unleaded Fuel Only - No Graphic.
Vent: Small hole in center of top of cap.

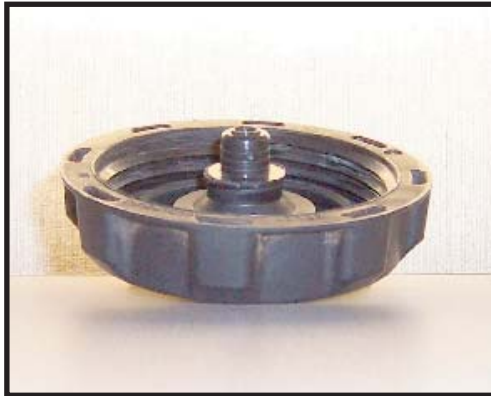
BOTTOM IDENTIFICATION

Vent: Single vent "tube" centered.

Most noticeable means of identification:

When shaken this cap "rattles." This is due to a steel ball that is used as an internal valve.

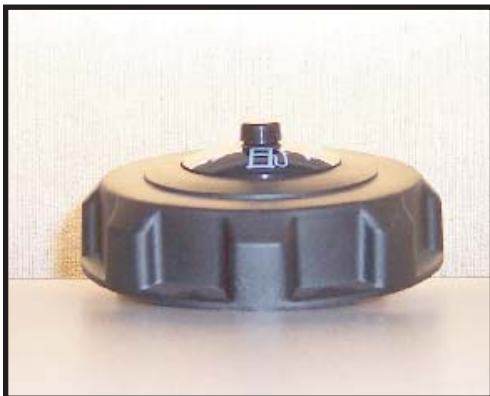
New Style Fuel Cap, P/N 181251

TOP IDENTIFICATION

Text: Unleaded Fuel Only - Fuel Pump Graphic.
Vent: Center hole is covered by a "hat."

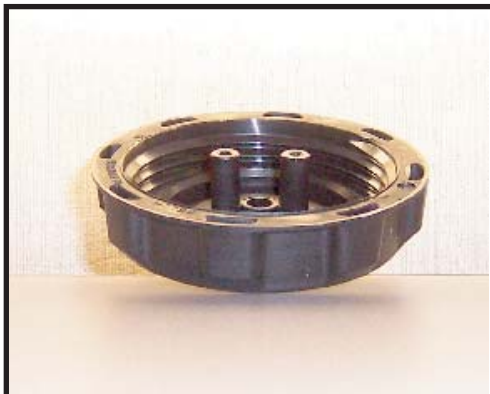
BOTTOM IDENTIFICATION

Vent: Double vent on either side of a "green" valve.

Most noticeable means of identification:

When cap is placed "right-side-up" on a flat surface, it will sit flat.
